Investigation of Motorized Glider ì In-flight Breakupî

John Tomblin, Yeow Ng
Wichita State University, Wichita, KS

Program Overview

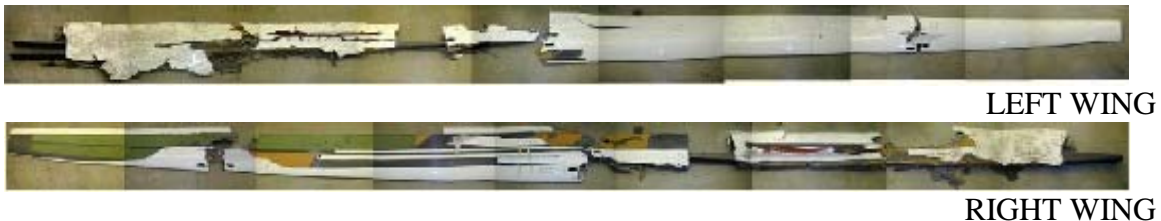
On July 13, 1999, at 1310 hours Pacific daylight time, a motorized glider experienced an in-flight breakup while maneuvering near Minden, Nevada. The commercial glider pilot and a passenger were fatally injured and the glider was destroyed. The personal flight was operated by the owner/pilot under the provisions of 14 CFR Part 91. The glider is certificated in the United States in the experimental category for exhibition and racing.

FIGURE 1. A PICTURE OF THE WRECKAGE
